FY99 Lessons Learned from Central Energy Plant Modernization Site Visits

November 2000

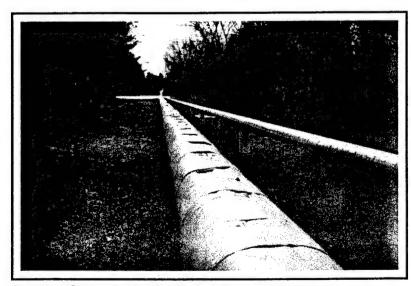
Figure 1. Steam distribution system lines.

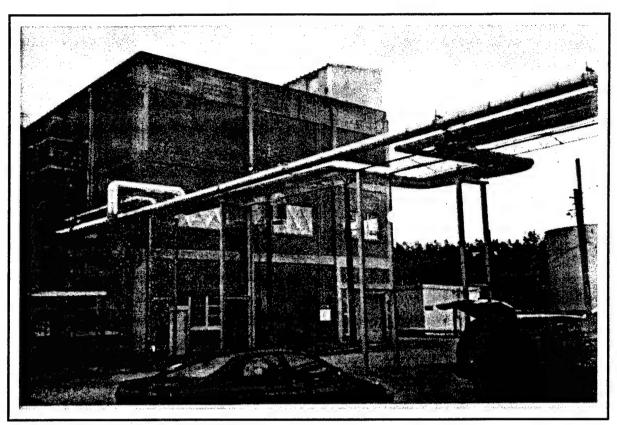
Figure 2. Old boiler plant (Building 3624).

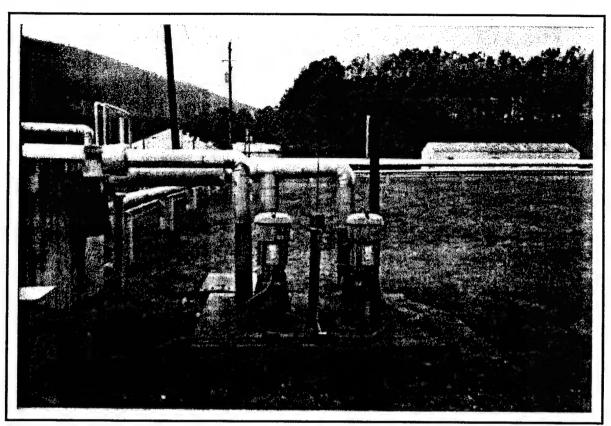
Figure 3. Metering station for point "a."

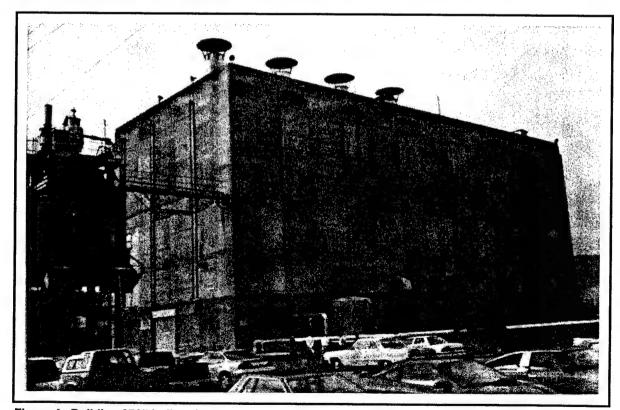
Figure 4. Building 2765 boiler plant.

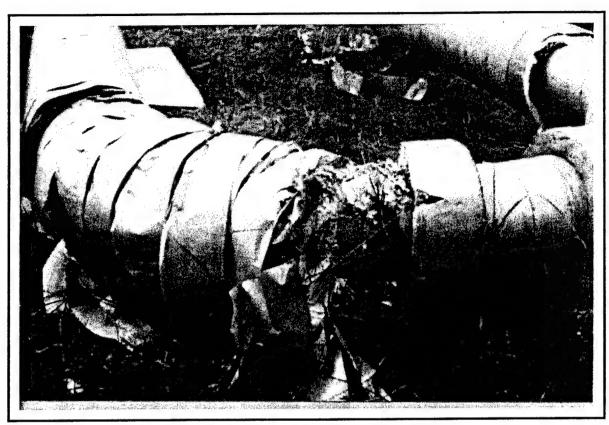
Figure 5. Steam distribution piping insulation and sheathing in poor condition.

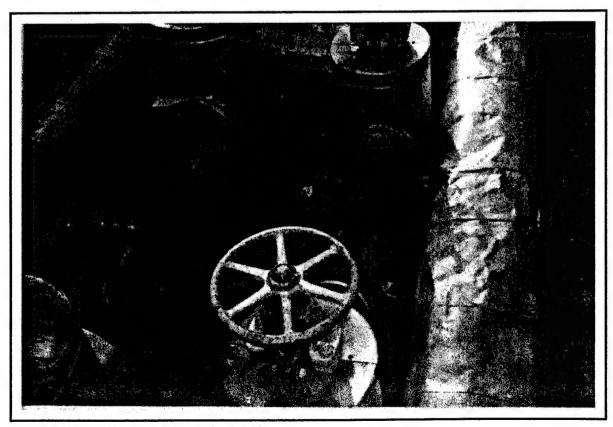
Figure 6. View of Redstone Arsenal valve pit.

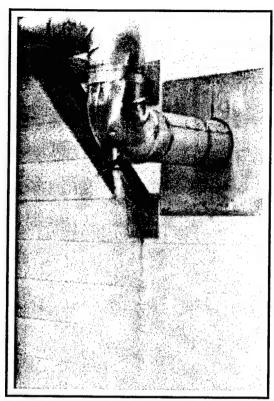
Parameter	Condensate Sample from Building 3628
pH	9.76
Temperature (°F)	72.68
Ammonia (mg/L)	17.40
Calcium (mg/L)	1.81
Copper (mg/L)	0.03
Iron (mg/L)	0.46
Magnesium (mg/L)	0.14
Cyclohexylamine (mg/L)	0.7
Diethylaminoethanol (mg/L)	3.8
Morpholine (mg/L)	0.3
Total Hardness (mg/L)	5.10
Methyl Orange Alkalinity (mg/L)	72.00
Conductivity (µmhos/cm)	116.00

Figure 7. Condensate drain and sampling point located at Building 3628.

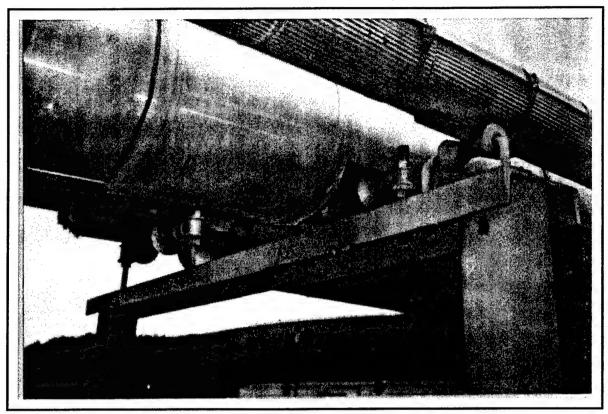
Figure 9. Distribution lines near point "b."

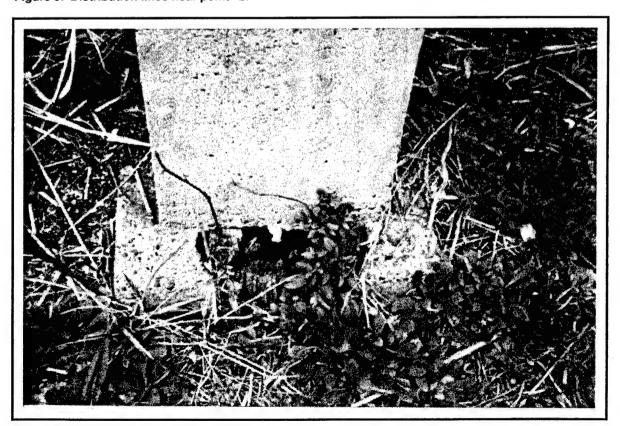
Figure 10. Piping support bearing problem.

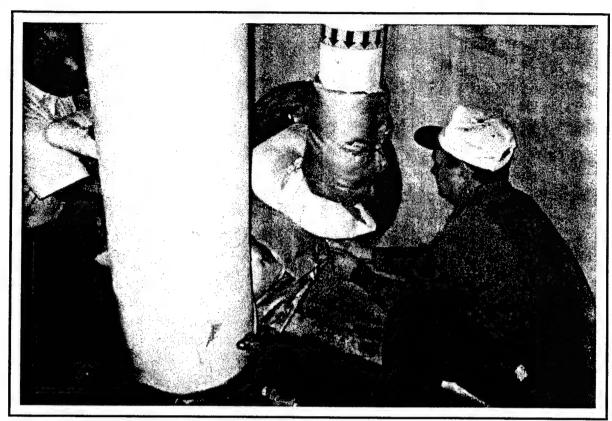
Figure 11. Entry point for steam supply for the Sparkman Center.

Researchers identified some design problems associated with the steam and condensate piping for the Sparkman Center. Both the steam supply and condensate return lines are located in a single, common conduit. This practice has not been allowed according to criteria for at least 15 years. The reason for this is that, on average, military installations do not always consistently perform effective internal pipe corrosion control through the use of water treatment chemicals. Since untreated liquid condensate is inherently more corrosive to steel than steam, after a number of years of service, the typical result is that the condensate line begins to leak. The presence of water within the conduit then serves to further degrade insulation, which increases the ambient temperature within the conduit. Increased heat loss also results. As the process continues, low-pressure steam is produced. This steam often can be seen rising out of the higher end of This steaming indicates ongoing, accelerated degradation and should not be ignored or allowed to persist. Within the conduit, the elevated temperatures in combination with the presence of water serves to accelerate corrosive degradation on the outside of the carrier piping. This further degrades the condensate piping and will lead to leaks in the steam supply piping.

Note that the condensate return line is located above the steam supply line. In some cases, the conduit itself has been sealed and used as a container for steam. This practice is strongly discouraged. The conduit piping is inherently inadequate for that application. Explosions could result. Another design error identified was the exceedingly long run of buried piping without a manhole. Current criteria limit the maximum length of buried pipe between manholes to 500 ft. Leak location and repair require more time, effort, and expense with longer runs.

To proactively mitigate this potential problem, the base should first closely and consistently monitor the chemical water treatment. For the Sparkman Center, specifically, the base should monitor the conduit vent on the high end and the conduit drain on the low end in the equipment room. An elbow should be added to the conduit vent on the high end now to prevent steam from blowing directly onto other piping and insulation. When a problem is observed, the first option should be perform a repair. If no treatment chemicals are found in the drained water, then the water source is likely to be groundwater. A conduit air pressure test can also be useful in determining conduit integrity. A second option is to not return condensate so as to preserve the steam supply line.

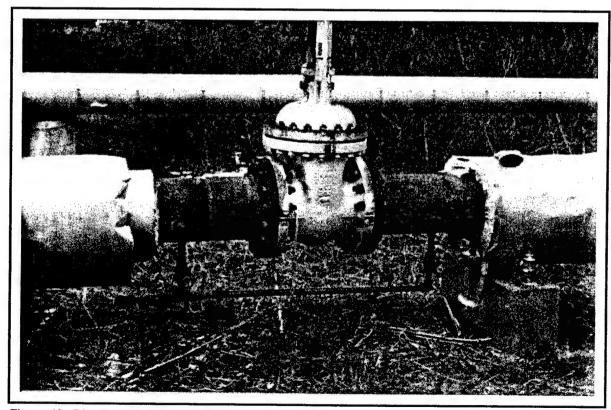
Figure 12. Distribution point "c" with startup bypass.

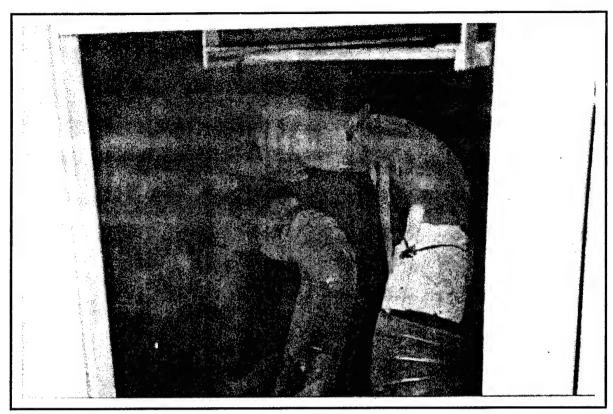
Figure 13. Steaming from distribution system manhole.

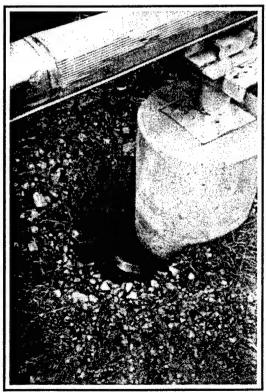
Figure 14. Soil erosion near piping support caused by a leaking valve.

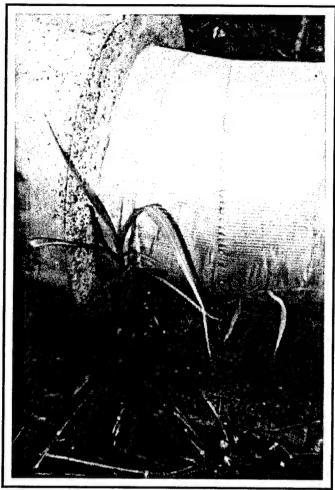
Figure 15. Fire ant colony located near heat distribution system piping.

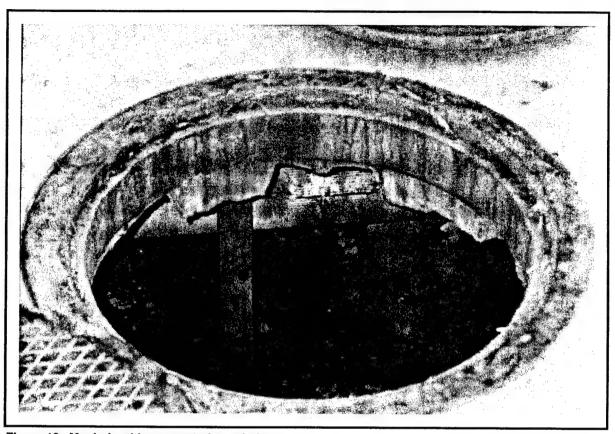
Of the few manholes examined there was one exception (in front of the barracks with the loud speakers on top) where the structural integrity of the concrete cover might be in doubt (Figure 16). It appeared that construction consisted of placing a corrugated metal plate across the span and then pouring concrete on top. It is unknown if any reinforcing bar was employed. It now appears that the corrugated metal plate is seriously corroded with sections of scale dropping on the piping and manhole floor. The 2-in. by 4-in. wooden supports observed (Figure 17) are a temporary fix at best. If in fact the corrugated metal plate is an essential structural element of the design, then structural integrity may be compromised. (The cracks in the concrete cover may or may not be related.)

Figure 16. Manhole with corrugated metal plate.

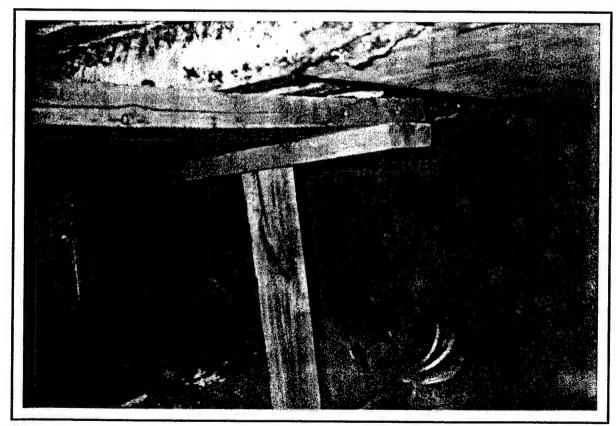
Figure 17. Temporary supports for manhole.

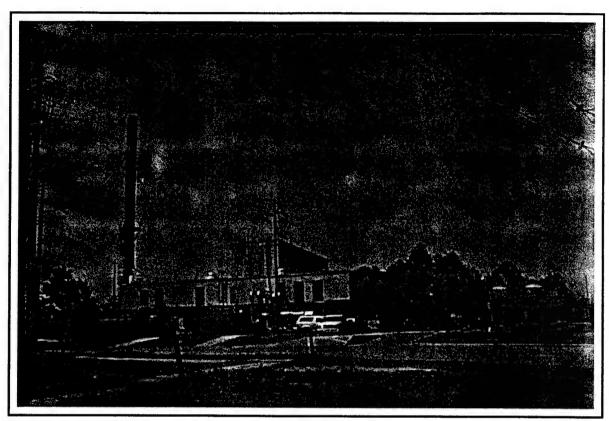
The team traveled to the heating and cooling plant (Building 25910, shown in Figure 19). Centralized heating and cooling is supplied to barracks, administration, and training facilities. There are a total of eight #2 fuel oil tanks - two 50,000 gal tanks on the north end, two 50,000 gal tanks on the east end, and four 50,000 gal tanks on the south end. A base contractor runs the plants. A piping replacement project was underway during the time of the site visit. There are five Erie City Iron Works boilers that were originally coal fired and now use oil or gas. Figure 20 shows one of the boilers. All five boilers will be replaced with three hot water (HW) generators. The chillers (Figure 21) will be replaced with a mix of chillers to adequately meet the load. Currently, there is over 6300 tons of cooling capacity. According to the Fort Gordon energy study, the existing chilled water distribution pumps will remain in operation, but the drives will now be controlled by variable speed drives. The free cooling system will operate primarily in the wintertime, and will use cooling towers only to obtain chilled water to be stored at 42 °F. Cooling towers would be replaced, with the resized cooling towers manifolded to each chiller. Water treatment would also be considered.

Figure 19. Fort Gordon heating and cooling plant (Building 25910).

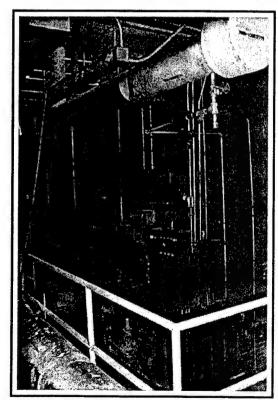
Figure 20. Erie City Iron Works boiler in Building 25910.

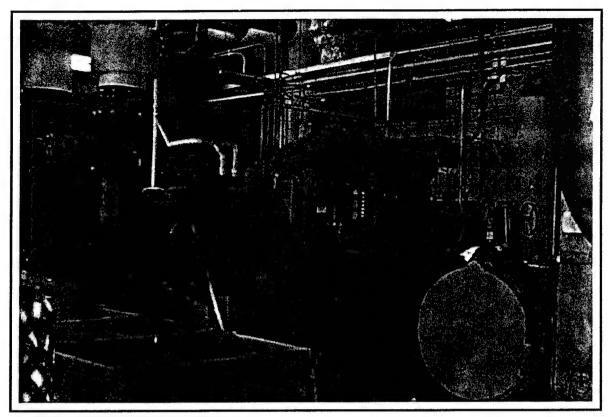
Figure 21. Chiller in Building 25910.

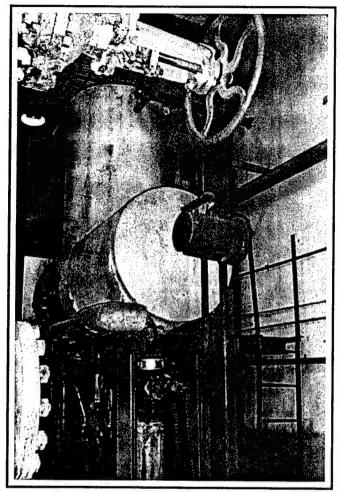
The team traveled to the second heating and cooling plant (Building 25330). The cooling plant (Figure 22) has approximately 2000 tons of cooling capacity. The chillers use R-123 refrigerant. The plant is operated manually, with maintenance personnel on shift. According to the Fort Gordon energy study, there is no need for the free cooling heat exchanger due to winter shutdown. Improving the efficiencies could reduce the energy baseline based on 1994 data. According to the Fort Gordon energy study, there are two steam generated boilers that will be replaced with hot water generators operating in a primary loop circulating HTW to the load via variable speed pumping. Chemical water treatment will be included in the scope of the project.

Figure 22. Inside chiller plant (Building 25330).

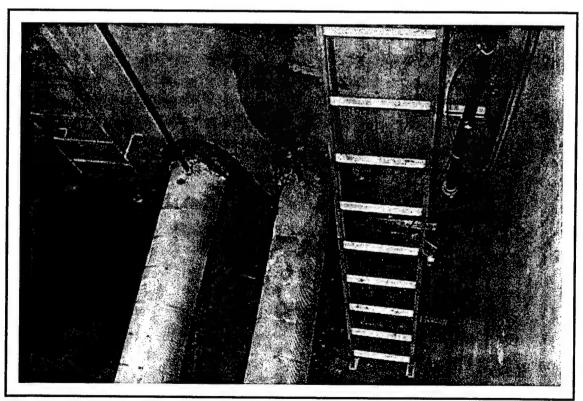
Figure 23. Casing corrosion of conduit at manhole wall penetration in Fort Stewart valve pit outside Building 410.

At each manhole CRREL visited, at least one vent pipe was steaming. All vents CRREL saw had been treated properly with standpipes coming up to near the surface level and "u" bends at top. CRREL saw a number of casings that were corroded through at the end plate juncture. A few of the manholes were suffering from the "perpetual pumping" scenario that results when the sump pump discharges to the surface at a manhole and it runs back in either over the sidewalls or through the soil. These could be remedied in most cases by extending the manhole side walls upward and locating the discharge downslope or just farther away.

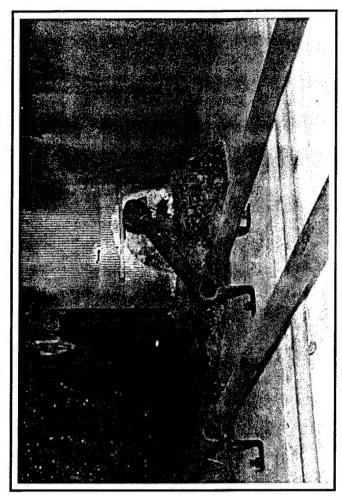
Figure 24. Casing corrosion in Fort Stewart valve pit outside Building 411.

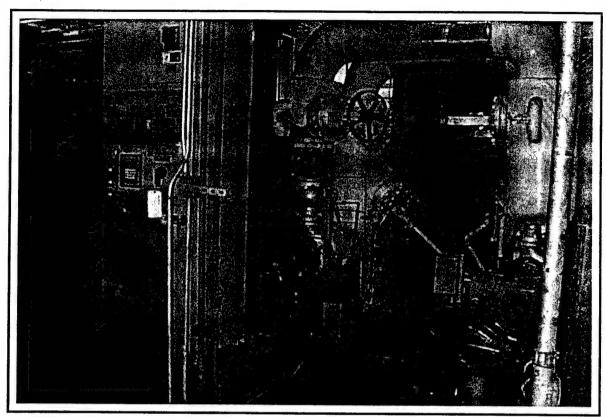
Figure 25. Chilled water piping and pumps in Building 1412.

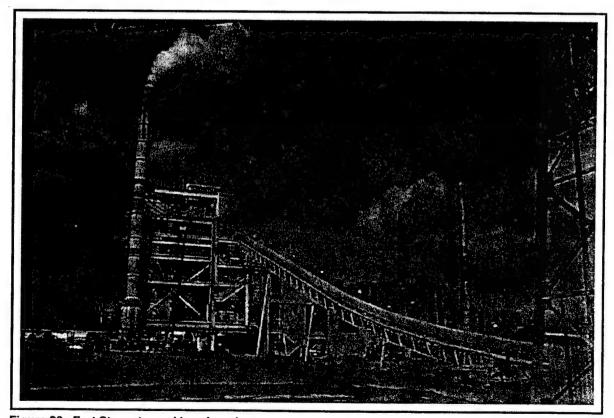
The team also visited the wood burning plant (Figure 26). The plant has an E. Keeler water-tube boiler, installed in 1983, with 94,900 lb/hr capacity. The stack has no economizers. The plant is operated by a control system using Honeywell controls. Figures 27 through 32 show additional pictures from these areas taken during the site visit.

Figure 26. Fort Stewart wood burning plant.

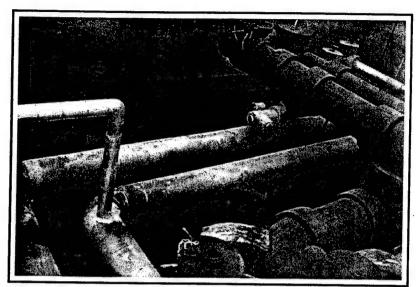
Figure 27. Condensate water leaks in valve pit.

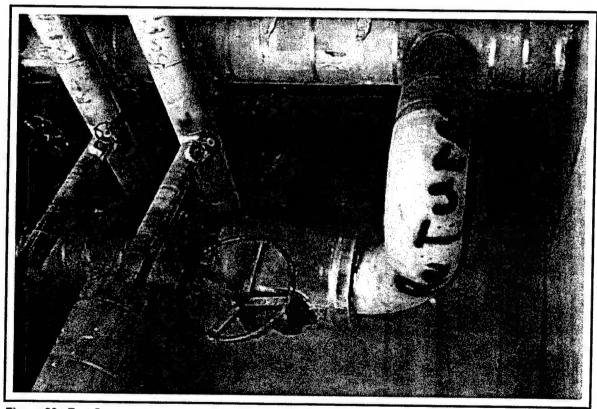
Figure 28. Fort Stewart steam distribution system return piping.

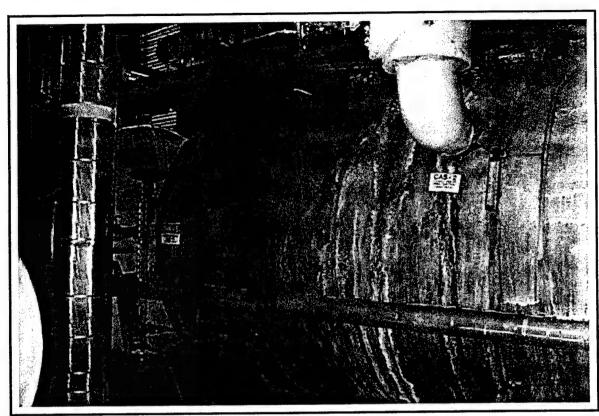
Figure 29. Makeup water tank at central plant.

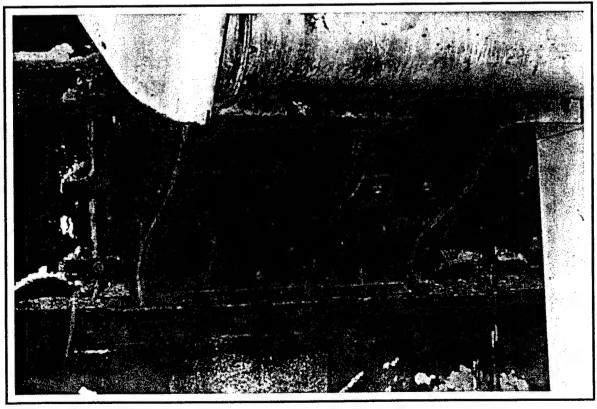
Figure 30. Corrosion in equipment.

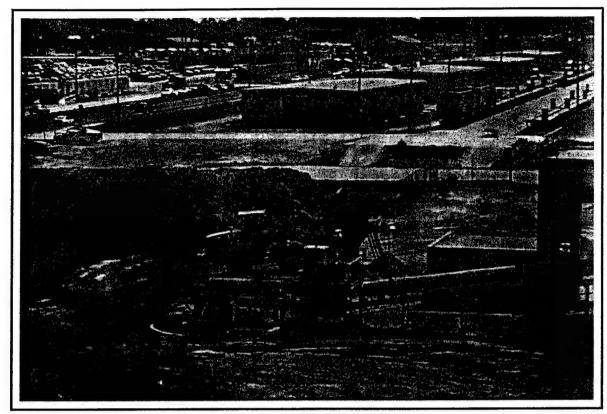
Figure 31. Wood supply area.

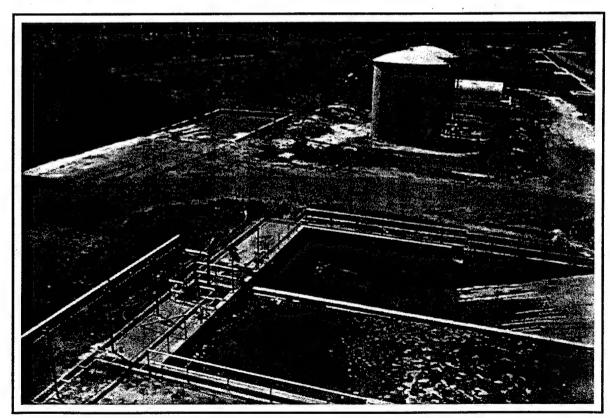
Figure 32. Scrubber waste storage.
